Pilot Project Monitor

PP Corridor:	PP4: Germany – Czech Republic – Slovak Republic – Ukraine – Russia
Involved Project Partners	<p>Association of Chemical Industry of the Czech republic (Coordinator);</p> <p>Association of Chemical and Pharmaceutical Industry of the Slovak Republic;</p> <p>Ústi Region Czech Republic;</p> <p>Ministry of Transport and Regional Development Saxony-Anhalt, DE;</p>
Subcontracted Experts	<p>DEKRA Automobil a.s., Prague, Czech Republic;</p> <p>University of Žilina, Žilina, Slovak Republic;</p>
Further involved Organisations:	<p>1. Trace:</p> <p>LC Slovaktrans, s.r.o.;</p> <p>LC Lauterbach Spedition - GmbH;</p> <p>METRANS, a.s.;</p> <p>LEVEL s.r.o.;</p> <p>OLTIS Group a.s.;</p> <p>DEKRA Automobil a.s.;</p> <p>NAM system, a.s.;</p> <p>2. Trace:</p> <p>Bohemiakombi spol. s r.o.;</p> <p>Trans-Sped-Consult s.r.o.;</p> <p>ČSPL a.s.;</p> <p>LEVEL s.r.o.;</p> <p>OLTIS Group a.s.;</p> <p>DEKRA Automobil a.s.;</p>

Selection/Preparation of hardware (Onboard Unit)

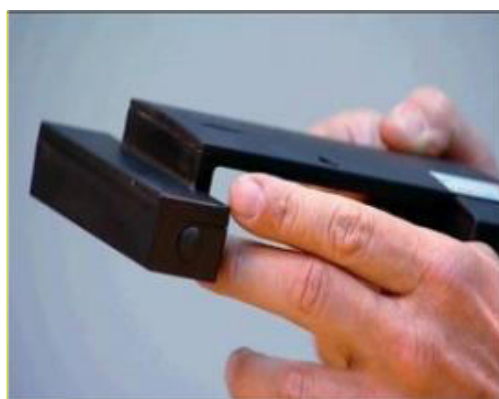
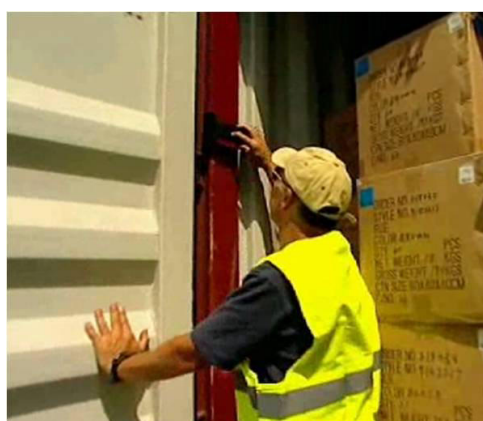
Photo documentation of the OBU unit for ISO containers:

Under the safety measures against vandalism and theft, it would be advisable that the OBU unit is as little visible as possible. With tank containers and complete trains, the OBU unit can be hidden in the underframe or behind the container frame. With ISO containers, the situation is somewhat more complicated. The company METTRANS pointed out a more elegant solution to this problem. There are OBU units which are placed and closed in the container door and the aerial is led out. The solution is shown in the below photographs. The company LEVEL, which provides the tested OBU unit, is able to produce, upon customer request, such design of the OBU unit which suits the customer. I.e. also a design similar to the one in the below photograph. Due to the fact that OBU units will be placed (removed, or checked) on containers by various – yet unidentified entities, standardization of the unit positioning on various types of containers is recommended.

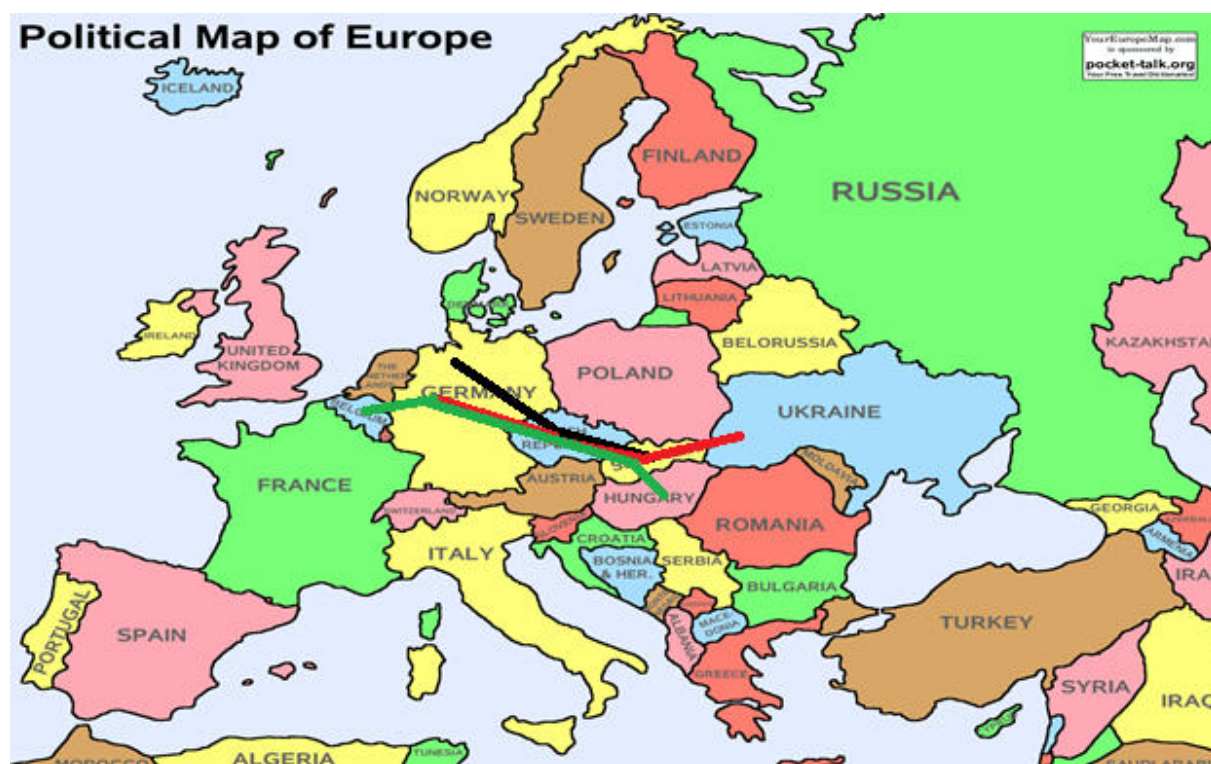
Graphical representation of all three routes on the map of Europe:

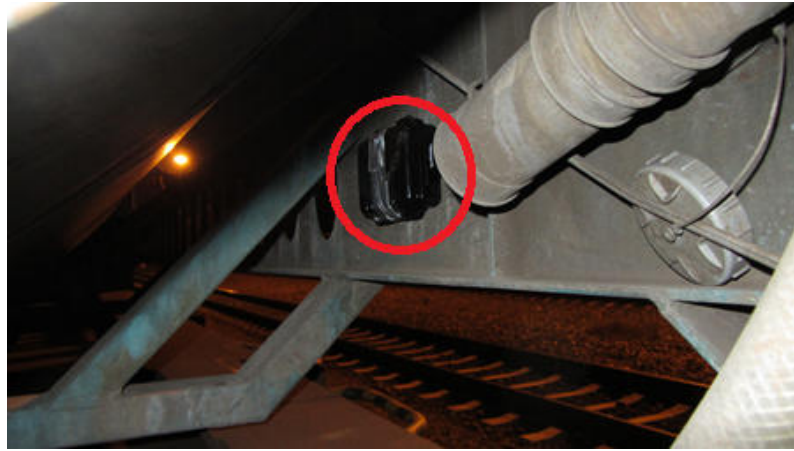
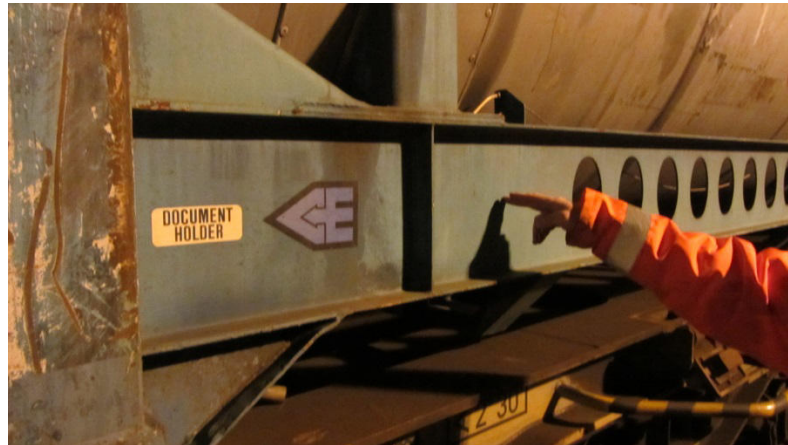
Photo documentation of the OBU unit attachment to a tank container of the company LC Lauterbach for route 1:

4. Loading took place on Monday 28.10.2013.
5. The container left Duisburg on Tuesday 29.10.2013.
6. The OBU unit was affixed to the container on 30.10., 8:15 p.m. in Prague. Magnets were used to affix the unit.

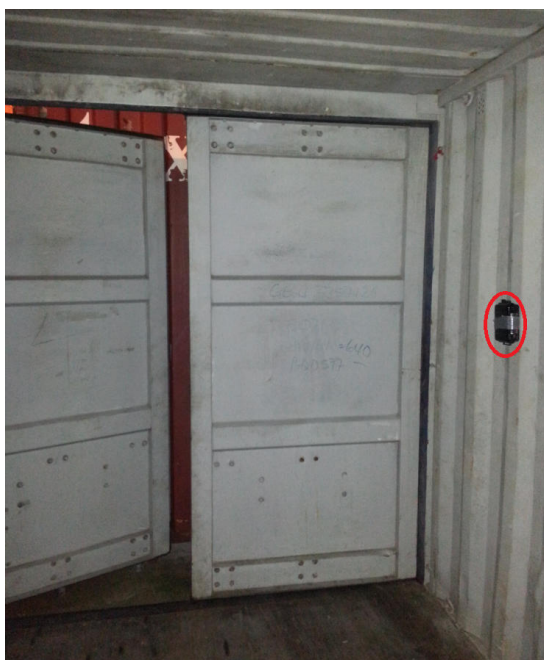
Below is a photograph showing the OBU unit enclosed in an ISO container:

We believe that a very good result is the situation when the unit reported from inside of the metal container with wooden flooring, thanks to which it was able to receive (by reflection from the ground) and transmit signal. Although one cannot rely on this fact, these findings would make it possible to identify the OBU unit even in emergency situations, when the unit is located in a metal packaging or container (e.g. finding it more easily when stolen, etc.)

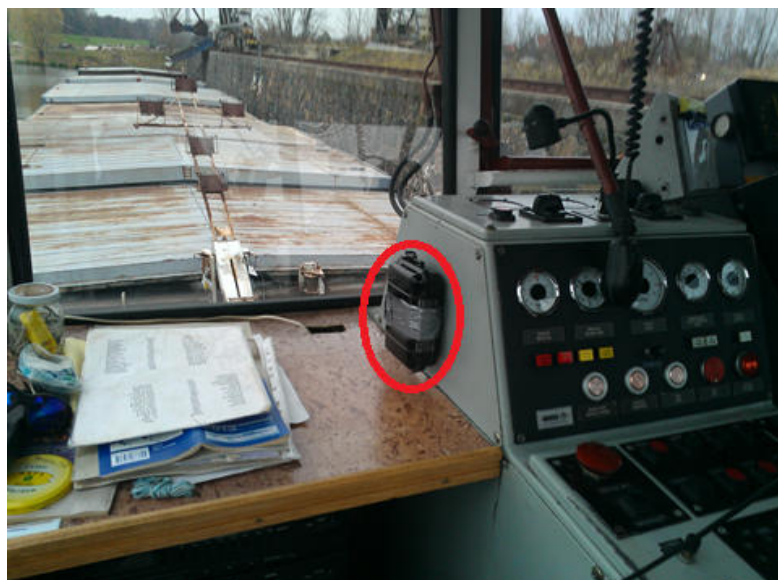
Photo documentation of the OBU unit attachment in a push tug TR 17 for route 2:

1. Due to the fact that container transport of dangerous goods is currently not being used on the Czech part of the Elbe, container transport by inland waterway is only a simulation. The OBU unit is located in the pilot house of a push tug.
2. The OBU unit was placed in the pilot house of a push tug TR 17.

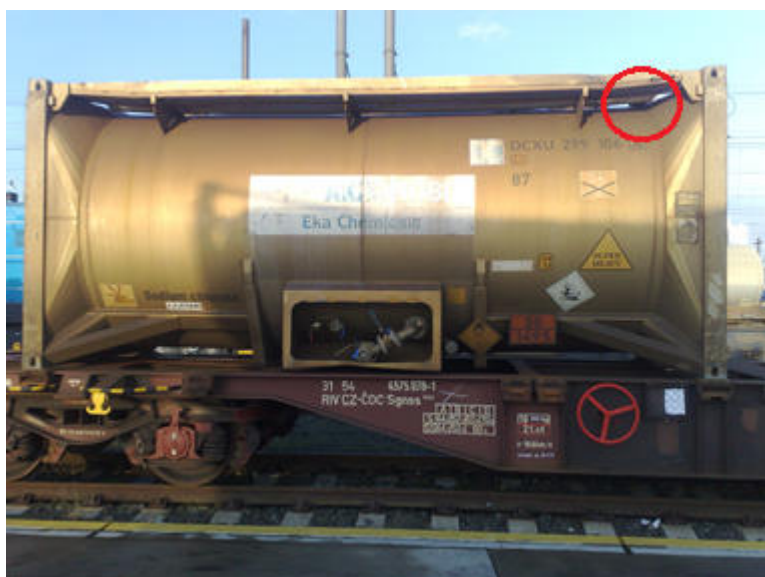
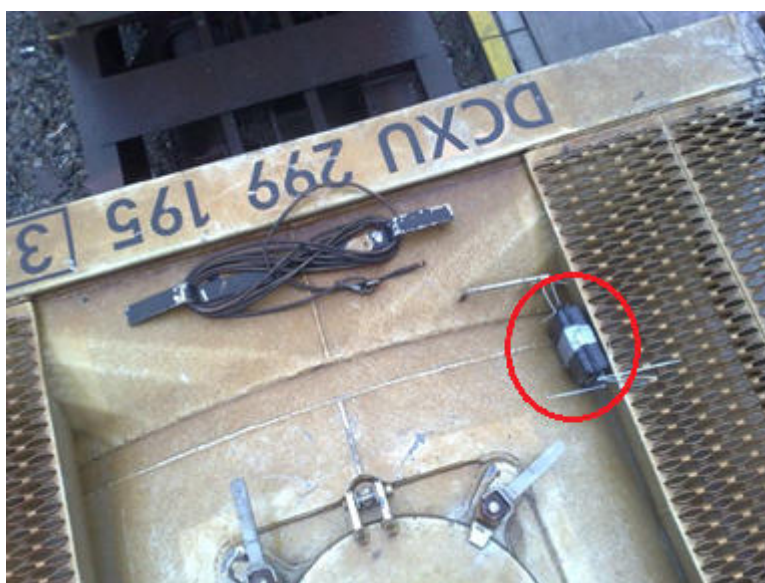
Photo documentation of the OBU unit attachment to a tank container of the company NTR for route 2:

10. The OBU unit was attached to a tank container of the company NTR no. DCXU299106-4 on 7.1.2014 in the evening hours. This container has been loaded on a railway car no. 31 54 457 5087-1 and sent on the Lovosice – Lisková route. The container is expected to return back to the Lovosice terminal in about one week.

the container identification in the below photographs). It is a transport of sodium chlorate UN 1495. The container is marked in compliance with RID regulations applicable for the railway transport of dangerous goods. Sodium chlorate is used mainly as a non-selective herbicide. From the chemical point of view it is a substance that is oxidizing, irritating and dangerous for the environment. In terms of transport, chlorate is classified in class 5.1 – oxidizing agent. Sodium chlorate causes barrenness of soil.

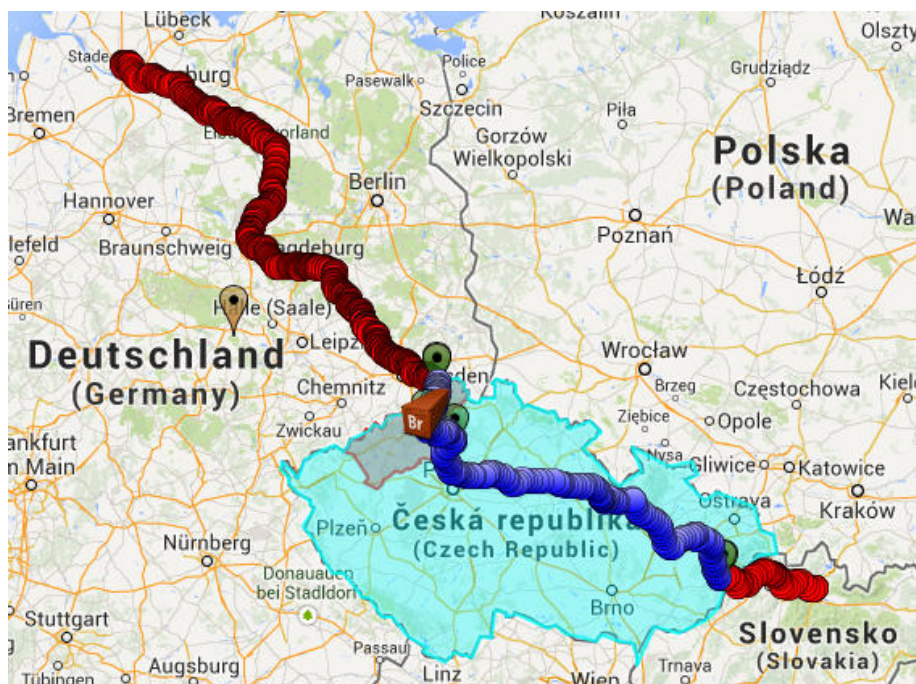
Record of route 2 in the DEKRA application:

<i>Note: A new function has been put into operation within the application which is able to generate and display the data of the individual routes as per the individual days. Previously, this function did not exist.</i>
Evaluation of Results	The tugboat with the OBU unit has completed the Děčín – Hamburg route and it is on its way back. The OBU unit was then attached to a tank container loaded on a railway car heading for Slovakia. Upon the arrival of the container in the destination station in the Lovosice terminal, the OBU unit was dismantled from the container.

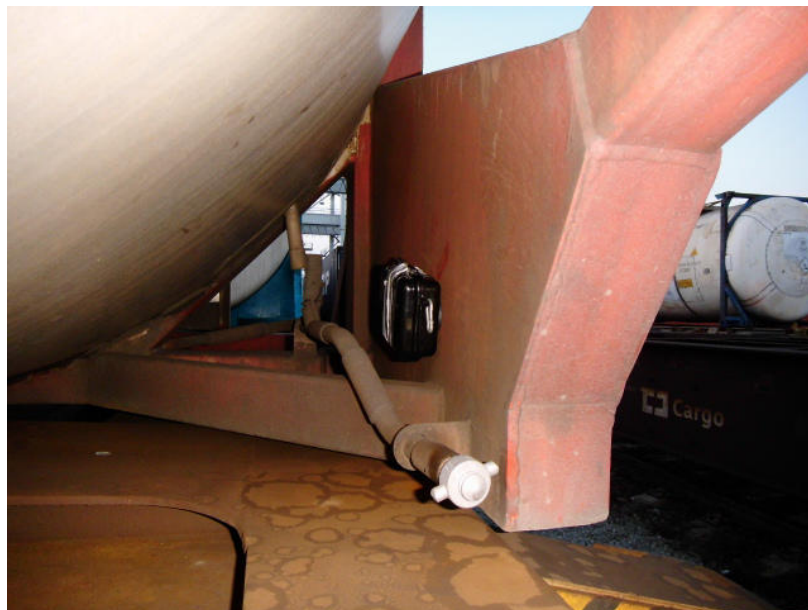
Photo documentation of the OBU unit attachment to a tank container of the company LC Lauterbach for route 3:

1. The selected container was a tank container carrying a dangerous substance.
2. The container number is RCLU3351052.
3. The haulage is ensured by the company Lauterbach Spedition-GmbH, Berg.
4. Loading took place on 2.2.2014 on the terminal of the company METRANS in Prague, Uhřetěves.

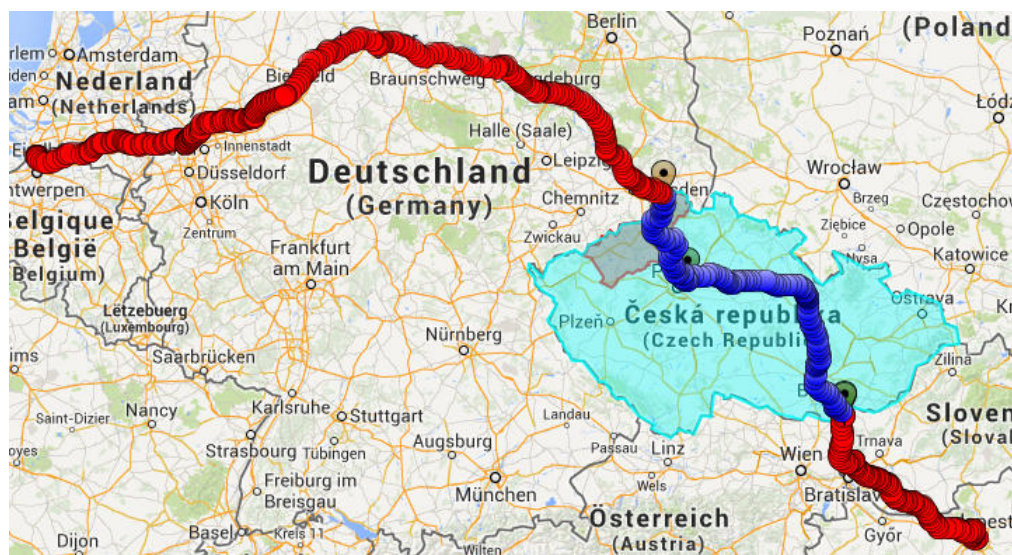
Result of pilot route 3 in the DEKRA application:

The container with the OBU unit passed through a predetermined route. The monitoring interval of the OBU unit was set to 3 minutes. On the stretch Duisburg – Prague, the reporting period was reduced to 90 seconds to test the behaviour of the OBU unit at a very low capacity.
